Technical Data Sheet

Bridge Identification:	1490230000000B01
Facility Carried:	US 2
Feature Intersected:	Cut River
Location:	Hendricks Township
County:	Mackinac
Region:	Superior
Year Built:	1941/1946
Year Reconstructed:	1953, 1979, and 1992
Bridge Type:	Cantilever Deck Truss
No. of Spans:	5
Deck Area:	24,249 S.F.
Paint System:	Type 4
Paint Area:	84,000 S.F.
Comments:	Historic Structure

General Bridge Description

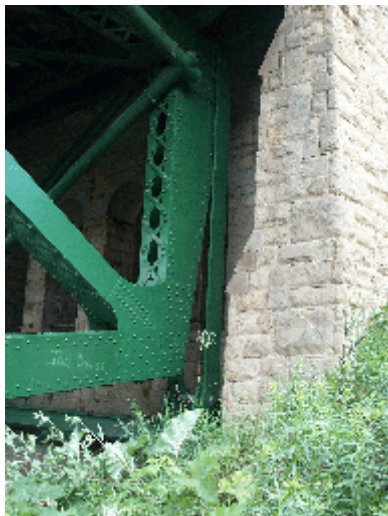
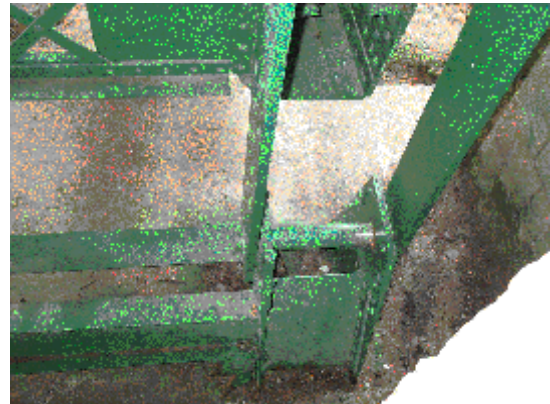
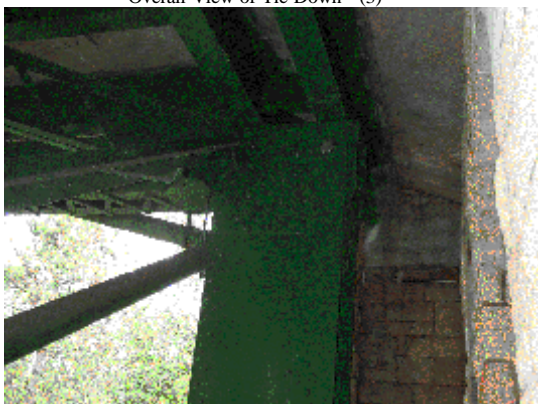
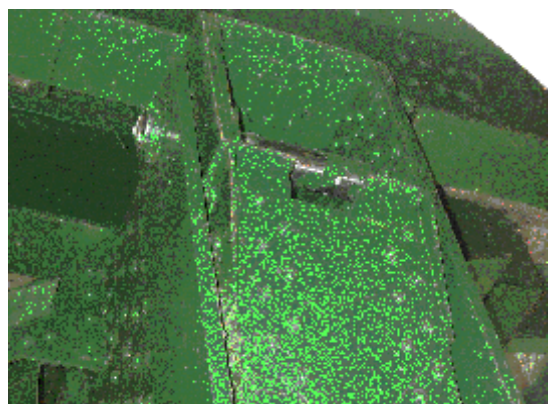
- !** **Tie-down members at abutments.** These pin and link assemblies (Photos 3 through 6) serve to anchor the trusses in Spans 1 and 3. The pin and link assemblies should be carefully inspected for cracks and loss of section and to ensure that they are free to move as intended.

Overall View of Tie-Down (3)

NE Tie-Down Bottom Pin (4)

NE Tie-Down Top Pin (5)

NE Tie-Down Top Pin (6)

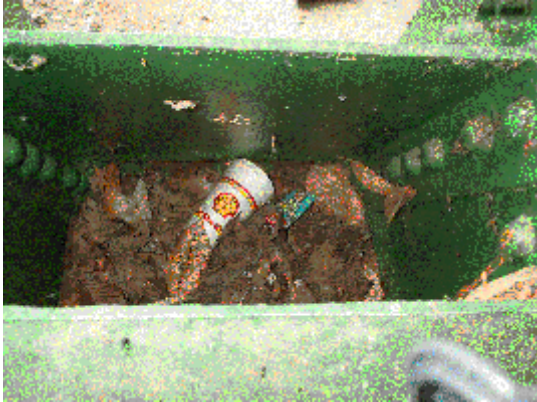
The bottom portion of the tie-down assembly is embedded in the abutment concrete. The resulting box configuration tends to accumulate dirt and debris that trap moisture at these locations (Photo

Debris in Tie-Down (7)

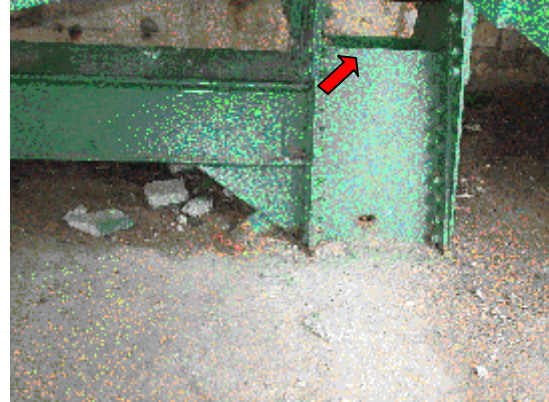
7). Check for corrosion and any associated section loss on these members at the abutment interface (Photo 8).

Section Loss on Tie-Down (8)

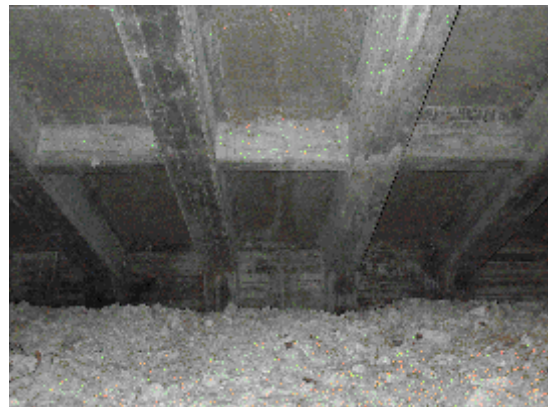
- ! **Reinforced concrete tee beam end spans.** These spans are accessible through manholes in the sidewalks at either end of the bridge or through doors in the abutment backwalls. These areas qualify as confined spaces and appropriate safety procedures should be followed. The concrete should be inspected for cracking, spalling, and general condition.

Inside of Concrete Tee Beam End Span (9)

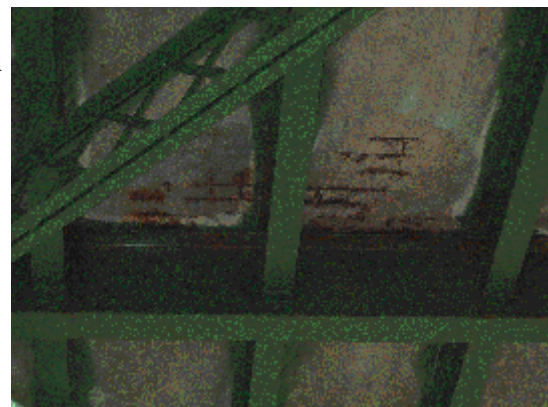
- ! **Deck.** Monitor condition of the underside of the deck. Compare extent of any spalling found with that documented in previous inspections.

Underside of Deck showing Spalled Concrete and Exposed Reinforcing (10)

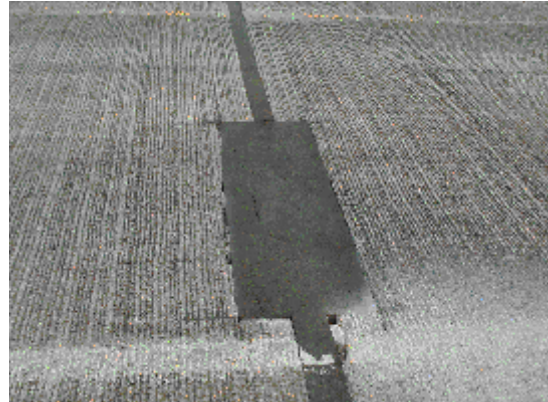
- ! **Deck cold joints.** Monitor condition of these joints, including the soundness of any previous repairs. These joints prevent water and dissolved chlorides from penetrating to the steel below. It is important that these joints be maintained in good condition.

Typical Deck Cold Joint (11)

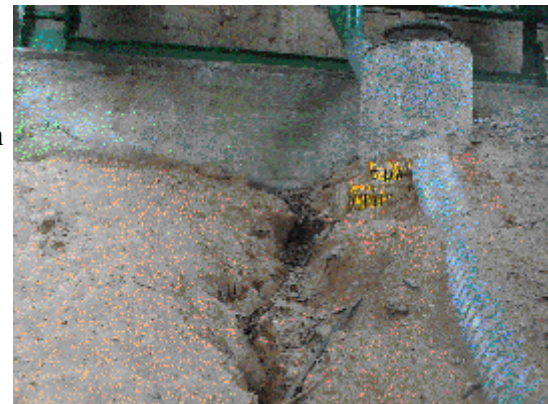
- ! **Erosion.** Monitor any erosion found near the centerline of the bridge at the east abutment. (Erosion at this location can occur when the bridge drainage system is leaking.) Compare with erosion documented in previous inspections.

Erosion at East Abutment (12)

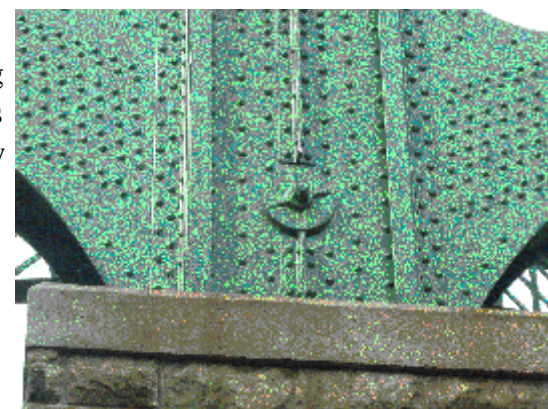
- ! **Truss bearings at piers.** Inspect the truss bearing assemblies, especially the pins, at the piers for signs of unusual wear or cracks. Inspect to ensure they are free to move as intended.

Typical Truss Bearing Pin (13)

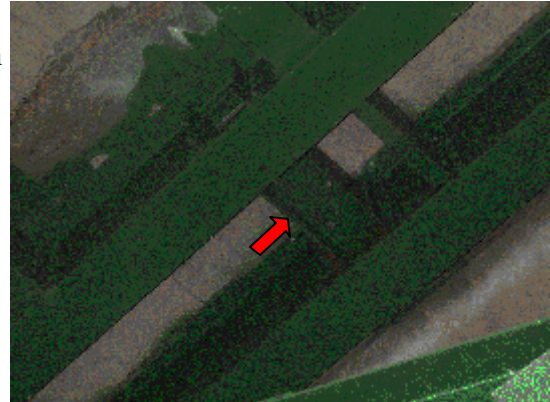
- ! **Wind tongue assemblies on end floorbeams.**
These members should be monitored for section loss. The members are wide-flange, steel sections with their webs oriented horizontally. This configuration allows the webs to hold moisture.

Wind Tongue Assembly (14)
